Building / Fire Safety & Parkside Estate

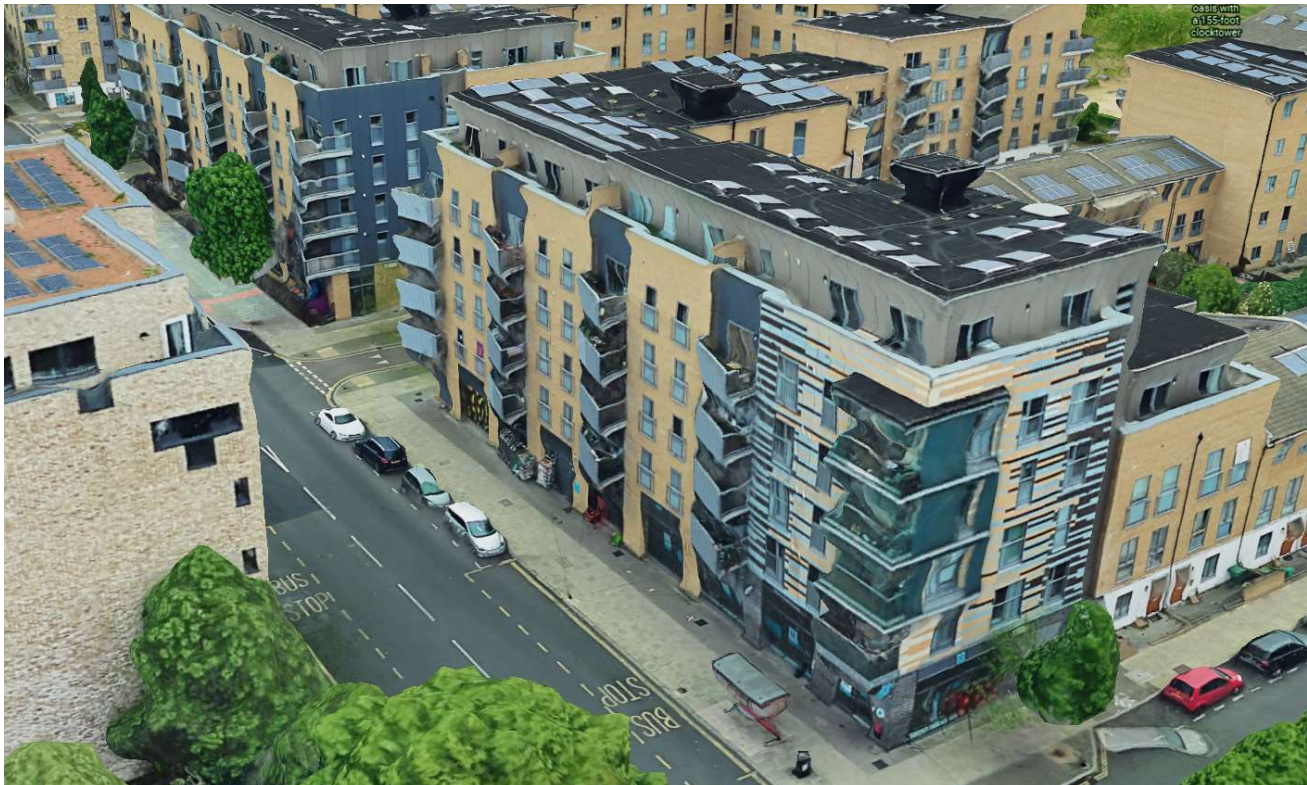
- **ACM / HPL**: flammable cladding installed and combustible insulation

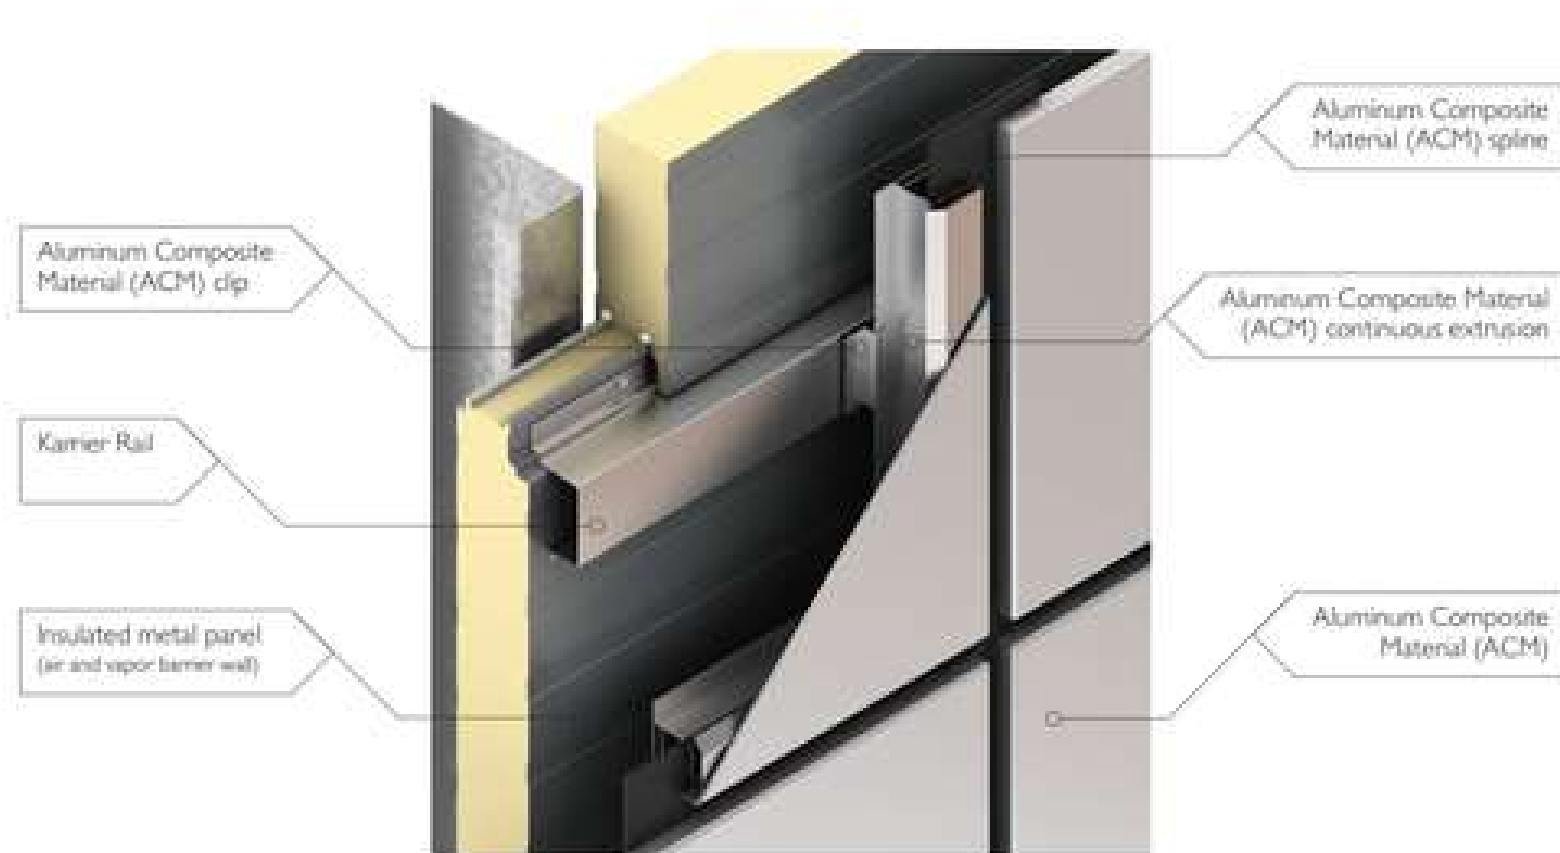
- **ACM:** Aluminium Composite Materials

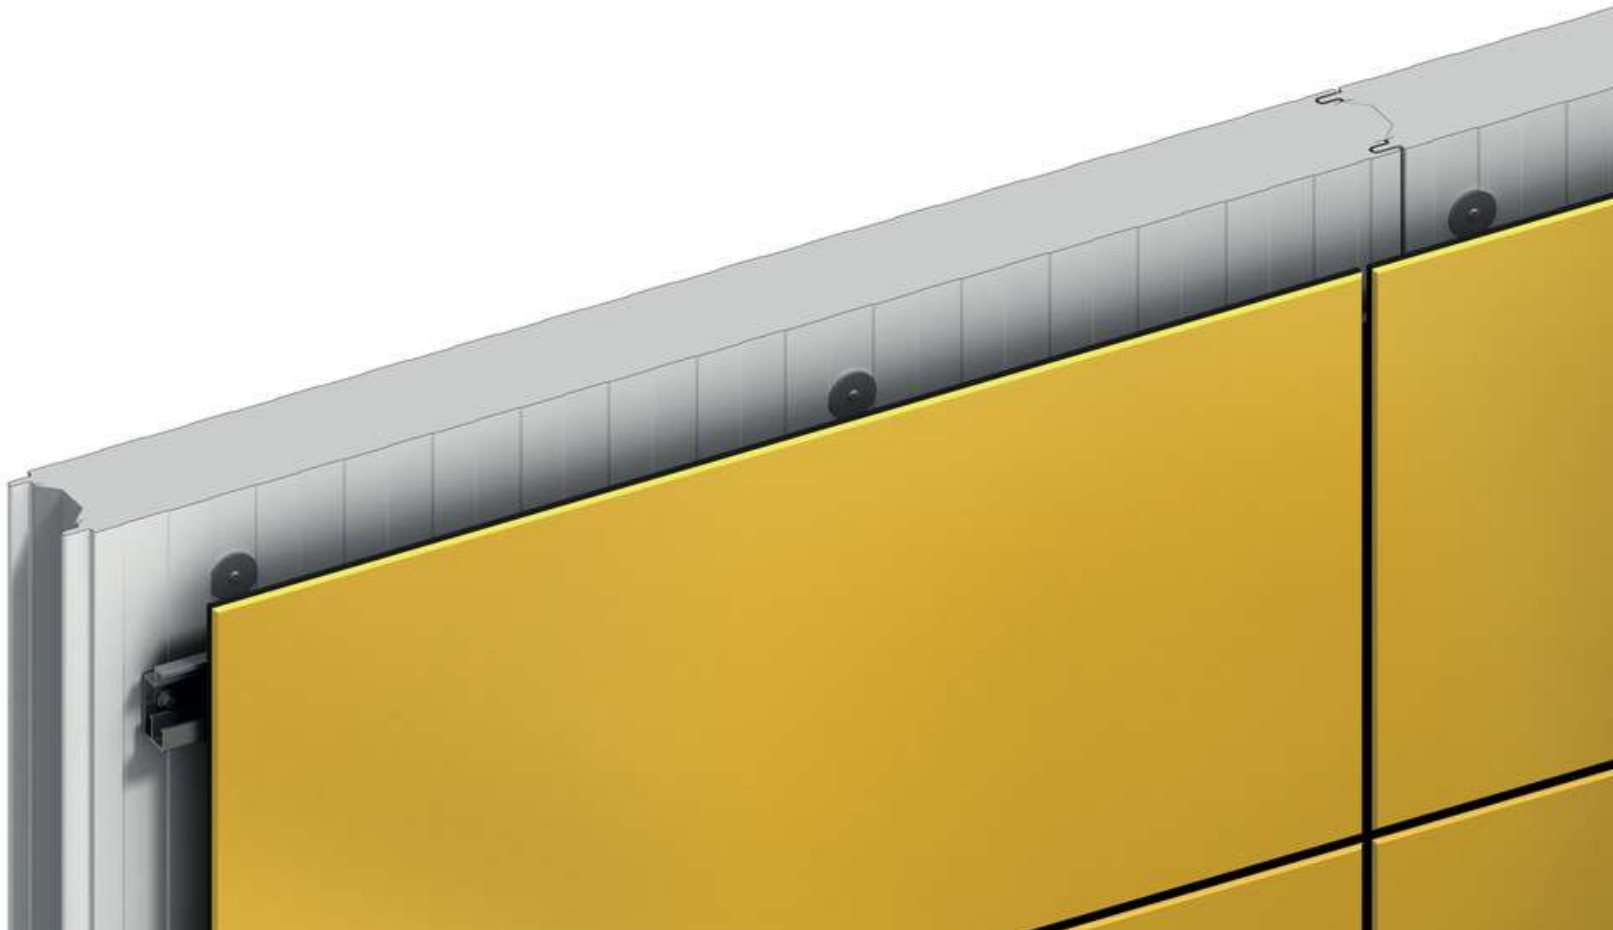
- **HPL**: High Pressure Laminate (Trespa)

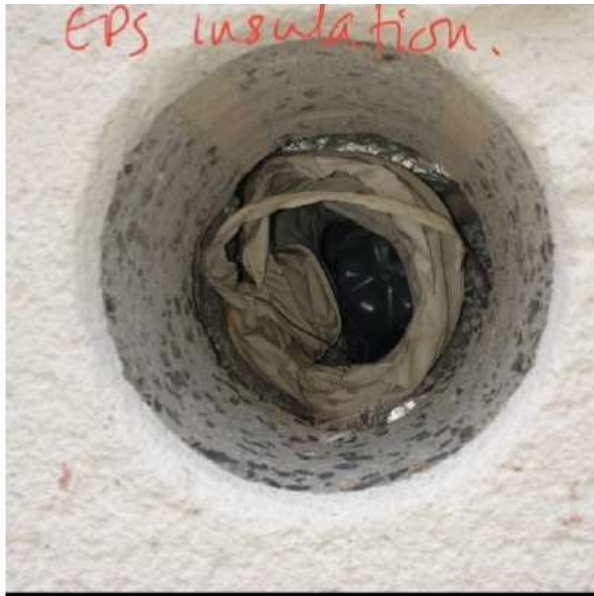
- **Fire barriers:** No cavity barrier around vent

Photo 2: Vent hole in cavity wall showing no fire break or cavity barrier around penetration.

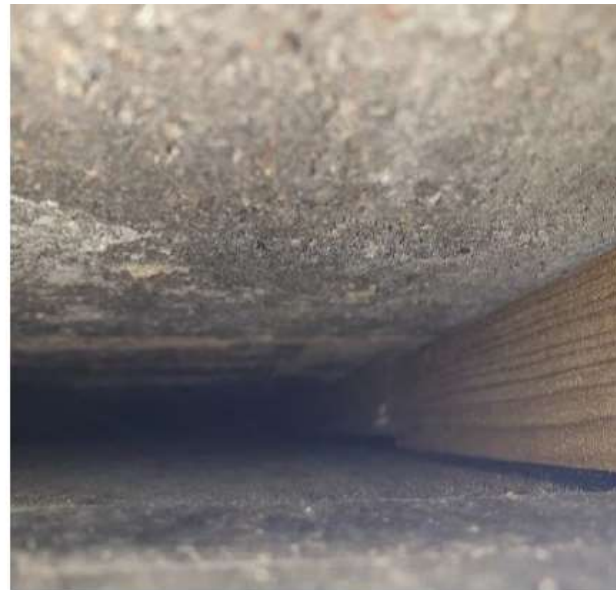
Photo 4: Adjacent to window reveal showing clear cavity and timber battens behind Trespa Meteor panel.

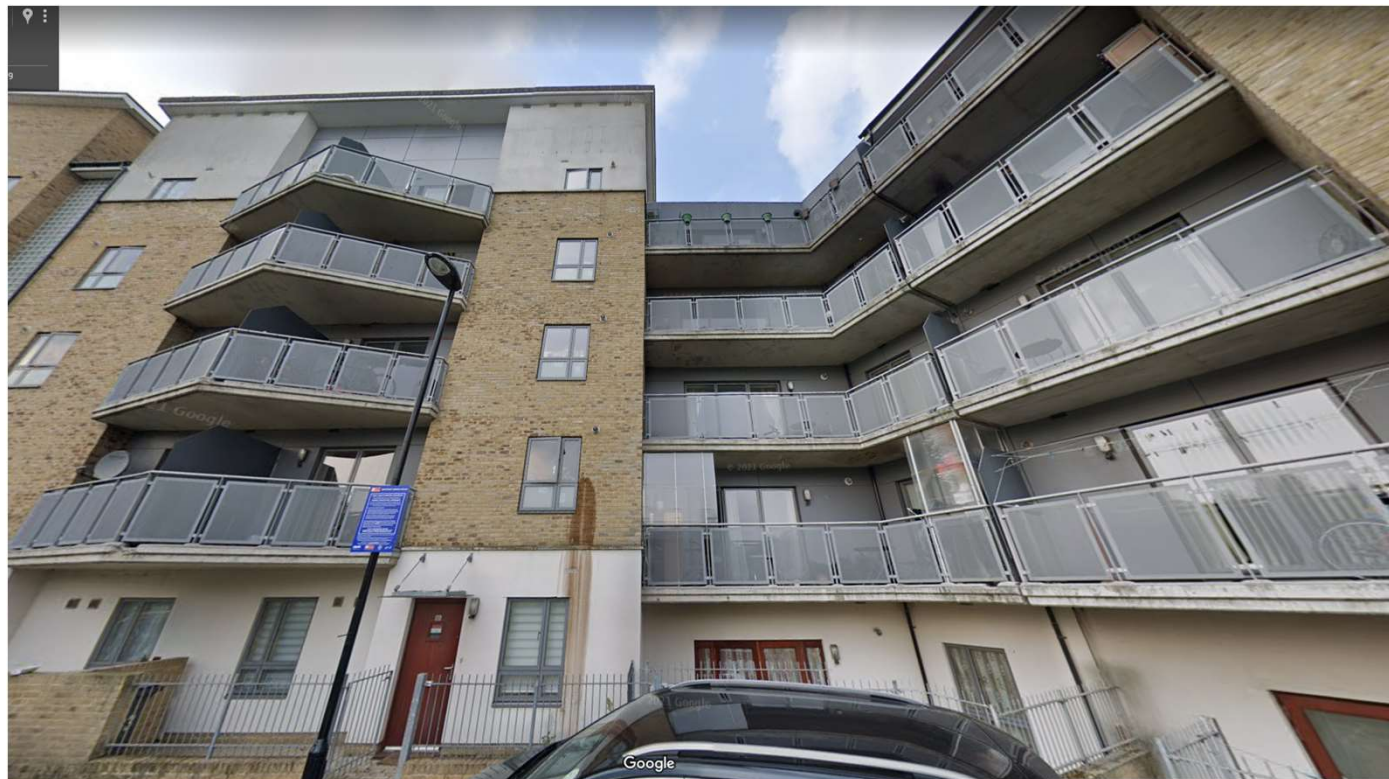
- **HPL behind balconies:** The balcony platforms are concrete and are creating a fire break between floors (vertically). Risk of horizontal spread between flats and blocks
