Building / Fire Safety & Parkside Estate

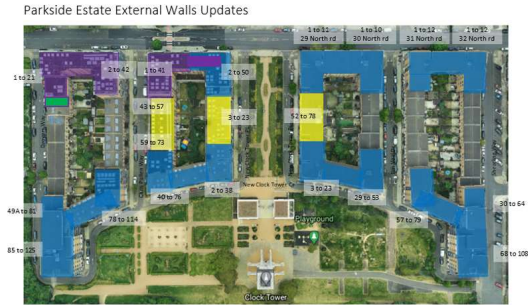
Risk Factor and Mitigation

Risk factors	<ul style="list-style-type: none"> • ACM cladding • HPL cladding • Provision of fire barriers • External wall penetrations • EWS1 potential rating: <u>B2</u> 	<ul style="list-style-type: none"> • HPL cladding • Provision of fire barriers • External wall penetrations • EWS1 potential rating: <u>B2</u> 	<ul style="list-style-type: none"> • HPL cladding is well-contained in safe structure • External wall penetrations • EWS1 potential rating: <u>B1</u>
Mitigation measures	<ul style="list-style-type: none"> • Southern Housing group is committed to design an adequate evacuation plan • The system may including heat detector and sounders • Southern Housing Group has commissioned a fire alarm specialist engineers to install a system that is suitable to detect fire problems from the external walls • Southern Housing group will use a smart alarm system that will detect the fire in the point of origin. Moreover, the system will also link the units close to the affected areas. 		<ul style="list-style-type: none"> • No mitigation action required • Ensure the current LD2 alarm is operating adequately.
